UNITED STATES COAST GUARD

INVESTIGATION INTO THE CIRCUMSTANCES
SURROUNDING THE COLLISION BETWEEN THE

M/V BALSA 37

ON AUGUST 10, 1993, WITH NO LOSS OF LIFE

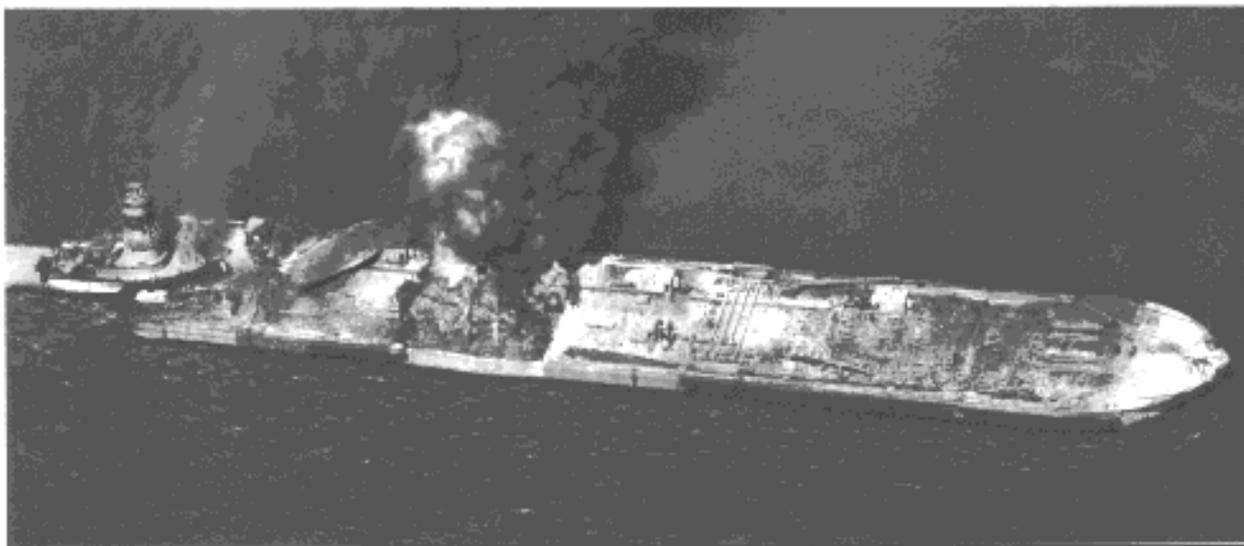
The SEAFARER tow grounded near Fort De Soto Park. Its No. 6 starboard tank exploded and the fire burned out of control until extinguished by the Tampa Fire Department that evening. The BALSAS 37 was grounded south of the channel near Egmont Key to prevent sinking. The BOUCHARD tow proceeded to anchorage near the Sunshine Skyway Bridge while continuing to release oil.

Fire aboard the T/B OCEAN 255

Initially, the OCEAN 255 was ablaze from stem to stern and there was fire on the water surrounding the vessel. Eventually the fire alongside the vessel burned out and the fires forward and aft of the No. 6 starboard cargo tank were extinguished. The fire in No. 6 starboard cargo tank presented the most significant problem to firefighters because the 16,098 barrels of Jet-A fuel were directly exposed to the atmosphere (the tank top having been blown off by an explosion).

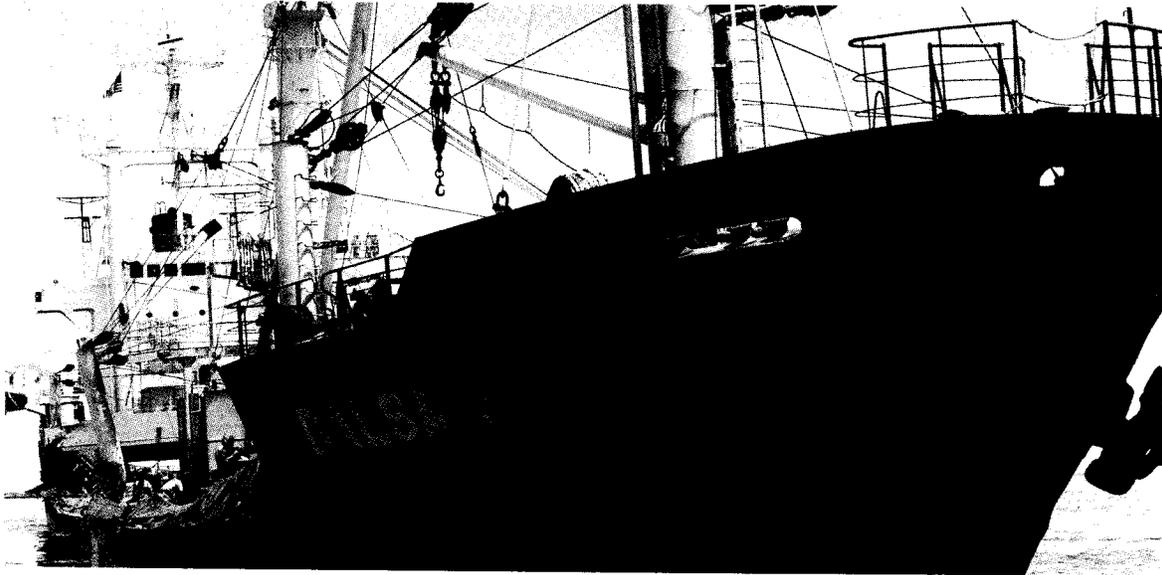
The M/V Balsa 37

At approximately 0545, the starboard bow of the OCEAN 255 struck the starboard side of the BALSAs 37 at the break of the forecastle. The force of the impact caused the BALSAs 37 to sheer to port and then back to starboard. Sparks and flames erupted and continued as the Ocean 255 raked the starboard side of the BALSAs 37. Black smoke filled the pilothouse of the BALSAs 37, and the smoke detection system automatically activated the general alarm. After the vessels separated, the SEAFARER tow continued past the starboard quarter of the BALSAs 37. The collision caused extensive damage to the BALSAs 37's hull and superstructure.

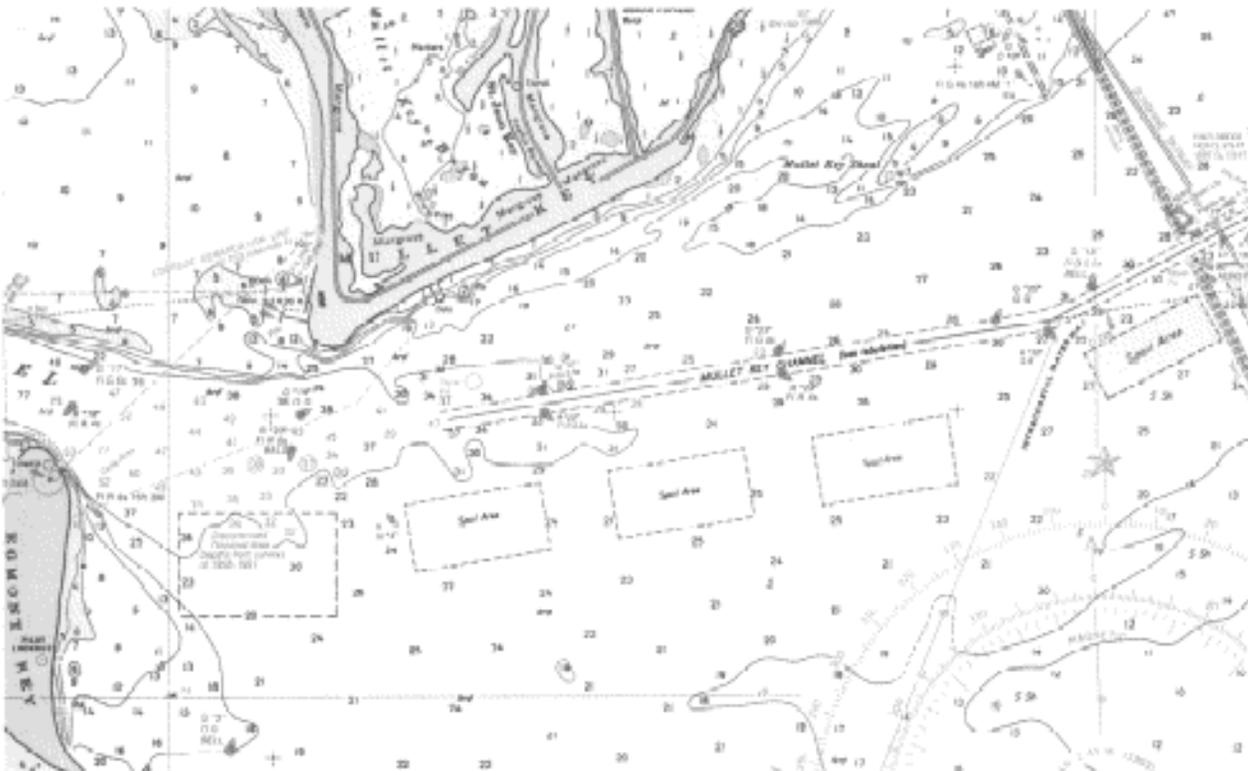
Figure 1 - Portion of chart 11414 showing the area of the collision

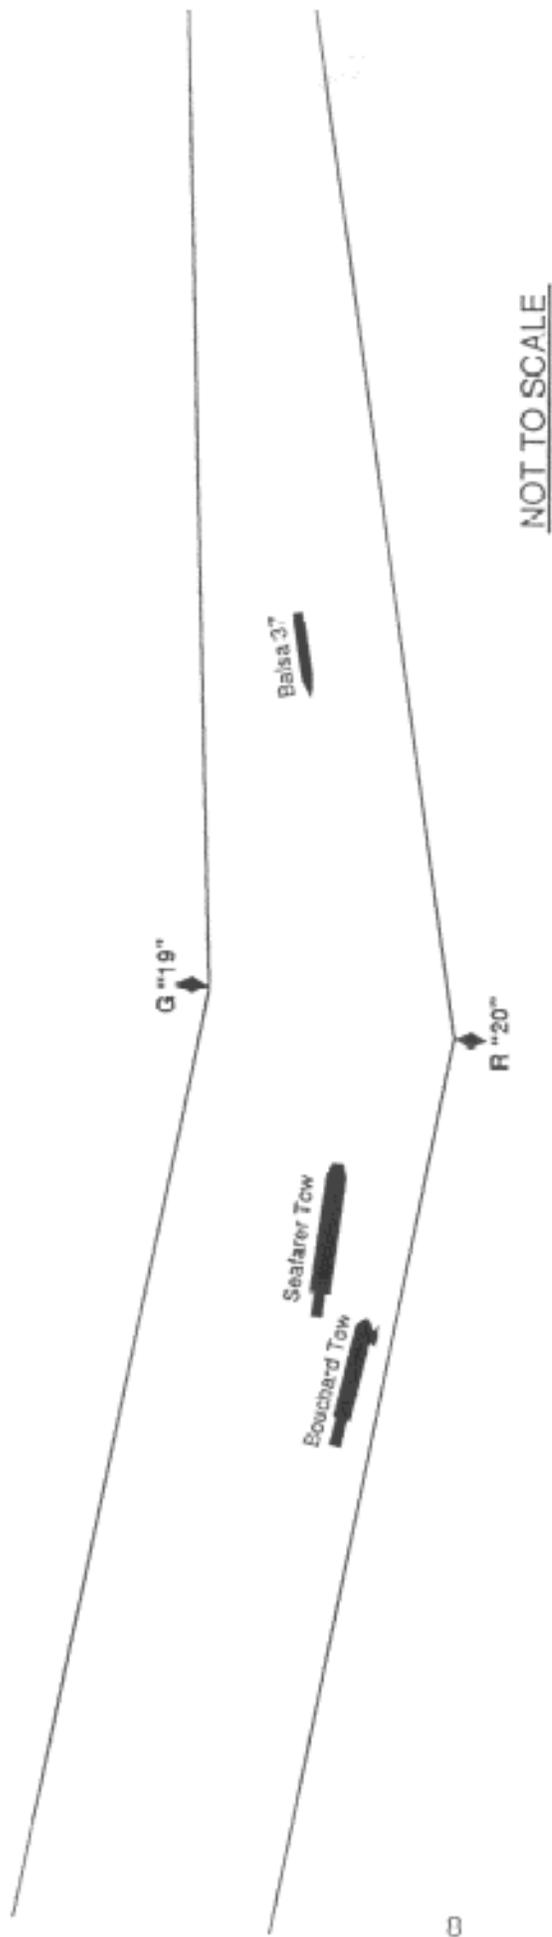
Figure 2

APPROXIMATE POSITIONS AS
VESSELS APPROACHED TURN
