National Transportation Safety Board

Marine Accident Brief

Accident No.: DCA-09-CM-001

Vessel: U.S. commercial fishing vessel *Katmai*, official number 918779, overall length 92.2 feet, registered length 73.3 feet, beam 26 feet, 148 gross register tons, 101 net tons, built 1987

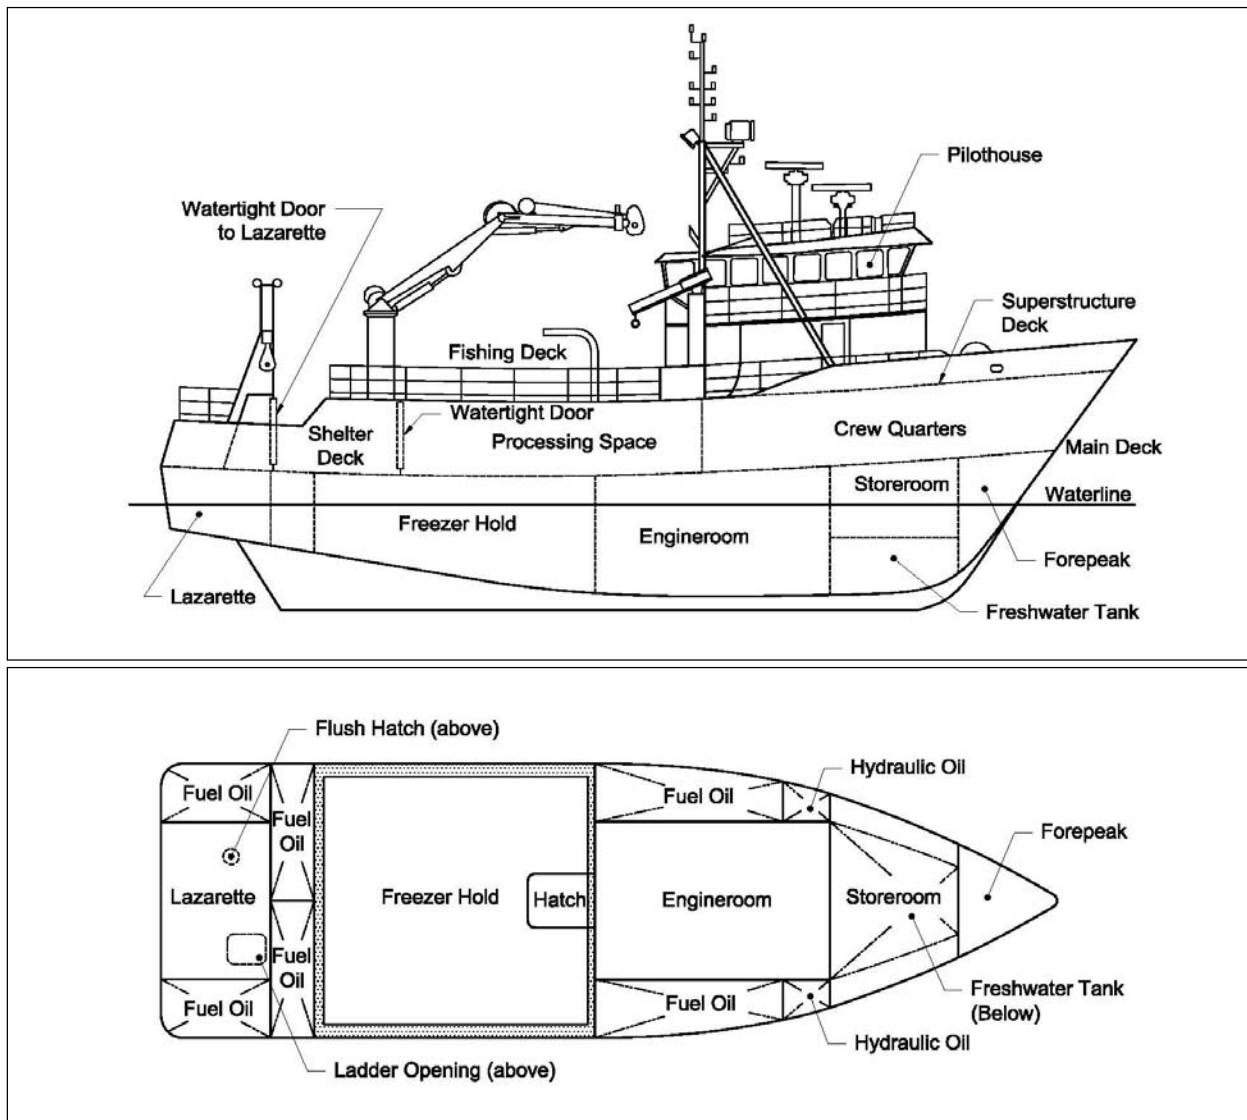
in bags that each contained 45 pounds of finished product, and stacked in the hold. The lazarette contained two hydraulic rams that positioned the rudders. The space also contained two refrigeration compressors and two hydraulic steering pumps as well as a portable dewatering pump.

Figure 3. Profile and internal spaces of *Katmai* (top) and layout below main deck (bottom). Drawing based on illustration in vessel’s 1996 stability report, recent vessel photographs, and testimony before marine board.

On the *Katmai*, the deck boss reported to the marine board that the watertight door to the processing space was physically deficient because light could be seen through the door when closed. In his testimony to the marine board, the master stated that the engineer reported that the door to the lazarette was open when he investigated loss of steering. The watertight door to the fish processing space was also discovered open after loss of steering. Watertight doors that are open or ineffective can allow water to enter the vessel and, depending on the internal integrity of decks and bulkheads, lead to progressive flooding. The Coast Guard Authorization Act of 2010 institutes new requirements concerning the watertight integrity of vessels. New vessels over 79 feet long must obtain load line certificates, requiring an annual survey to verify the condition of the hull and openings. Vessels less than 79 feet long must be examined every 2 years to verify the physical condition of the hull, openings, and internal structure. At this time, it is unknown how or when the Coast Guard will implement this new statutory authority.

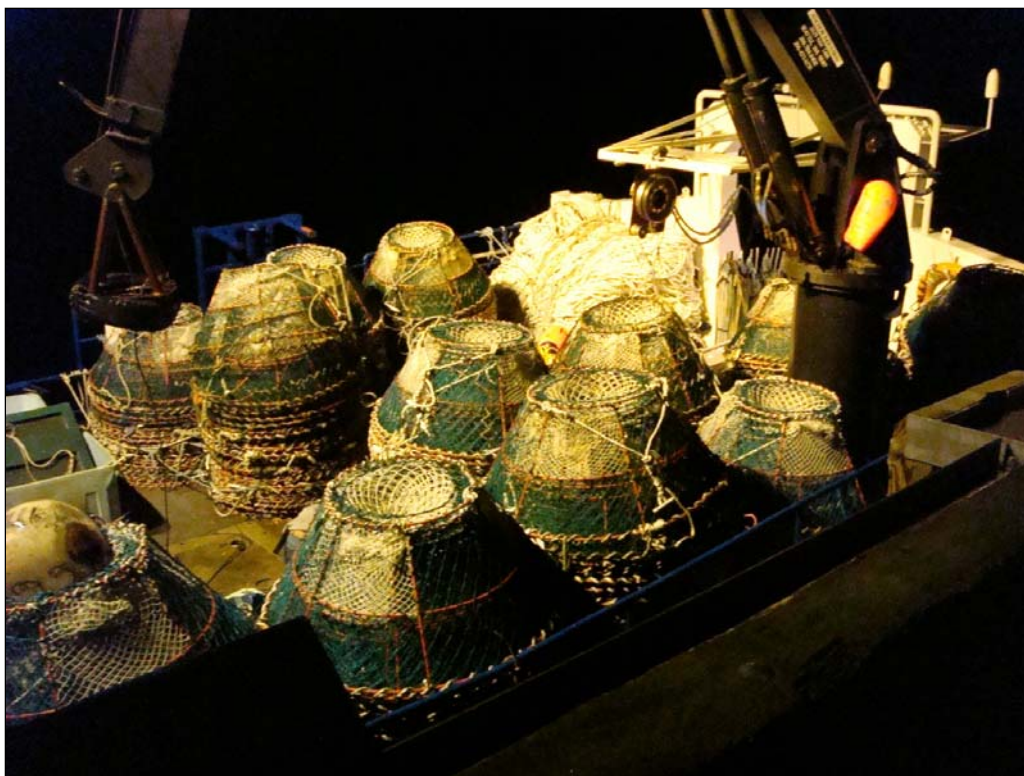
Figure 4. Cod pots on *Katmai*'s fishing deck, looking aft (Katmai Fisheries, Inc., photograph).
