## Marine Accident Brief

**Accident No.:** DCA-09-LM-010

**Vessel:** U.S. commercial fishing vessel *Lady Mary*, official number 520834, 76-foot length overall (71.2-foot documented length), 105 gross registered tons, 21.2-foot beam steel construction, built 1969, converted 2001

**Accident Type:** Sinking

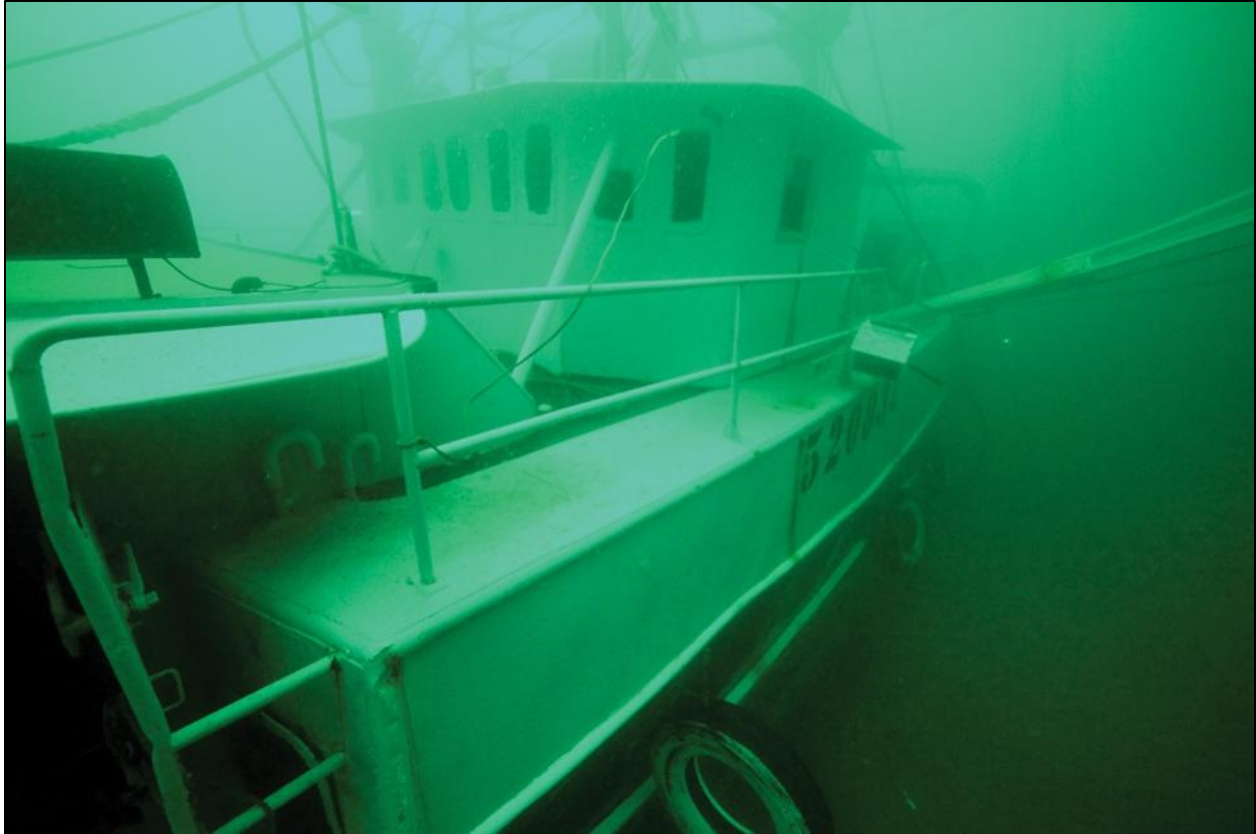
The wreckage was surveyed by divers in May 2009 and extensively photographed (figure 2). In October 2009, the Coast Guard, with the assistance of the U.S. Navy, retrieved the rudder and other equipment from the sunken vessel, which was sent for analysis to the materials laboratory at NTSB headquarters in Washington, DC. As of the date of this brief, the Coast Guard had not published its report on the *Lady Mary* accident.

**Figure 2.** Sunken wreckage of *Lady Mary*, May 2009. (Photo by Bradley Sheard)

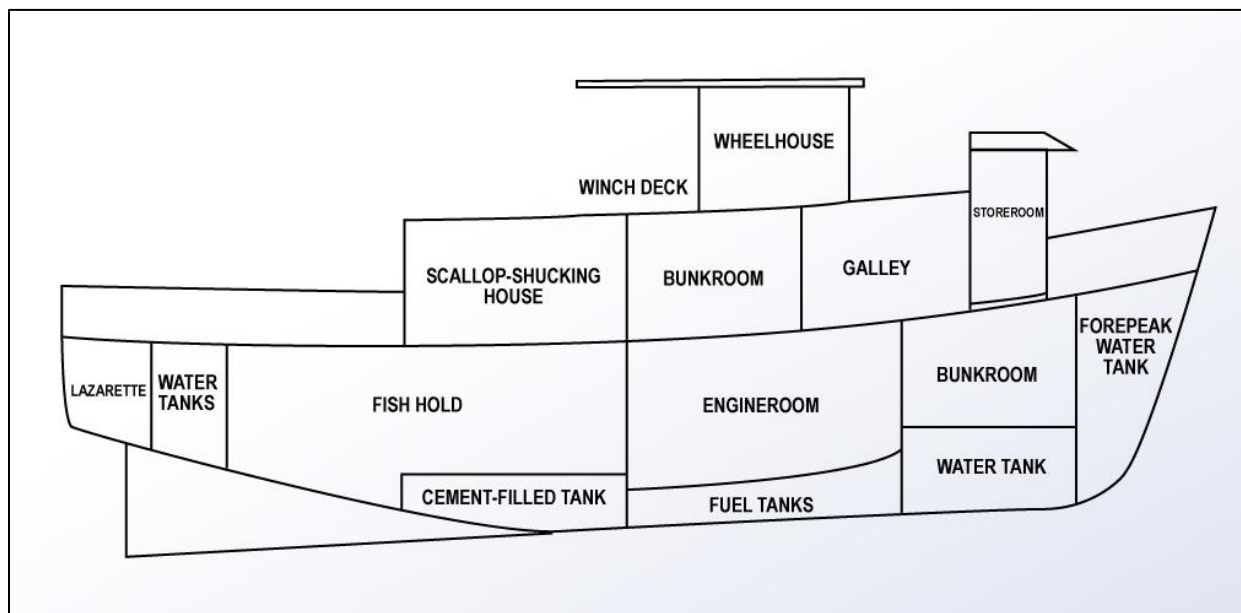
**Figure 4.** Profile view of *Lady Mary* (drawing based on Coast Guard sketch, not to scale).

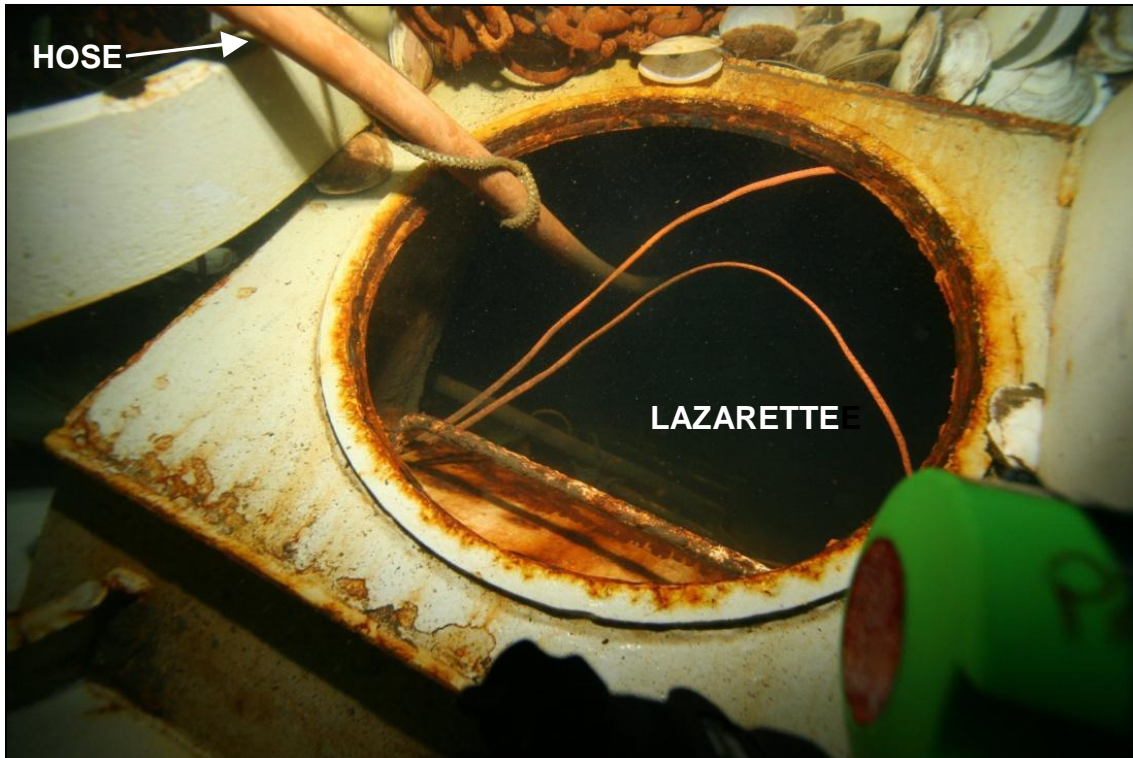
The photographs showed that the lazarette hatch on the main deck was open. A hose that emerged from the lazarette through the open hatch was tied overboard by a rope (figure 6). Although not shown in the photographs, a pump was positioned inside the lazarette, according to both the surviving crewmember and the owners' representative. The survivor told investigators that when it was necessary to dewater the lazarette, a crewmember would remove the hatch cover, enter the lazarette, rig the pump by hand, and empty the space using a hose that discharged over the side. He stated that the lazarette would typically be pumped out three or four times on a 10-day trip, and—in bad weather—they would have to pump it out "about once a day."

**Figure 6.** Open access hatch to lazarette, showing hose emerging from inside and tied overboard. A vessel's lazarette is its aftermost compartment below its main deck, typically accessed by a deck hatch. (Photo by Paul Whittaker)

Postaccident photographs of the *Lady Mary* wreckage show that the cover to the lazarette access hatch was off, with a hose emerging from the open hatch and tied overboard. According to testimony, the hose was attached to a pump in the lazarette. The survivor did not recall whether the lazarette hatch was open or closed when he went to bed. He said, however, that the crew normally kept the cover closed, as is consistent with safe shipboard practice, unless they were pumping out the lazarette.

The National Transportation Safety Board determines that the probable cause of the sinking of the *Lady Mary* was flooding originating in the lazarette through an access hatch that had been left open during rough weather, contrary to safe shipboard practice. Contributing to the delay in the dispatch of rescue assets was the inability of the EPIRB to transmit position data following activation.
