Commanding Officer  
United States Coast Guard  
Marine Safety Office

16700/MC98016578  
October 2, 2000

Subj: SUPPLEMENTAL REPORT ON THE DISAPPEARANCE OF THE COMMERCIAL  
FISHING VESSEL LINDA E (O.N. 236906), WITH THREE CREWMEMBERS  
NEAR PORT WASHINGTON, WI ON LAKE MICHIGAN ON DECEMBER 11, 1998

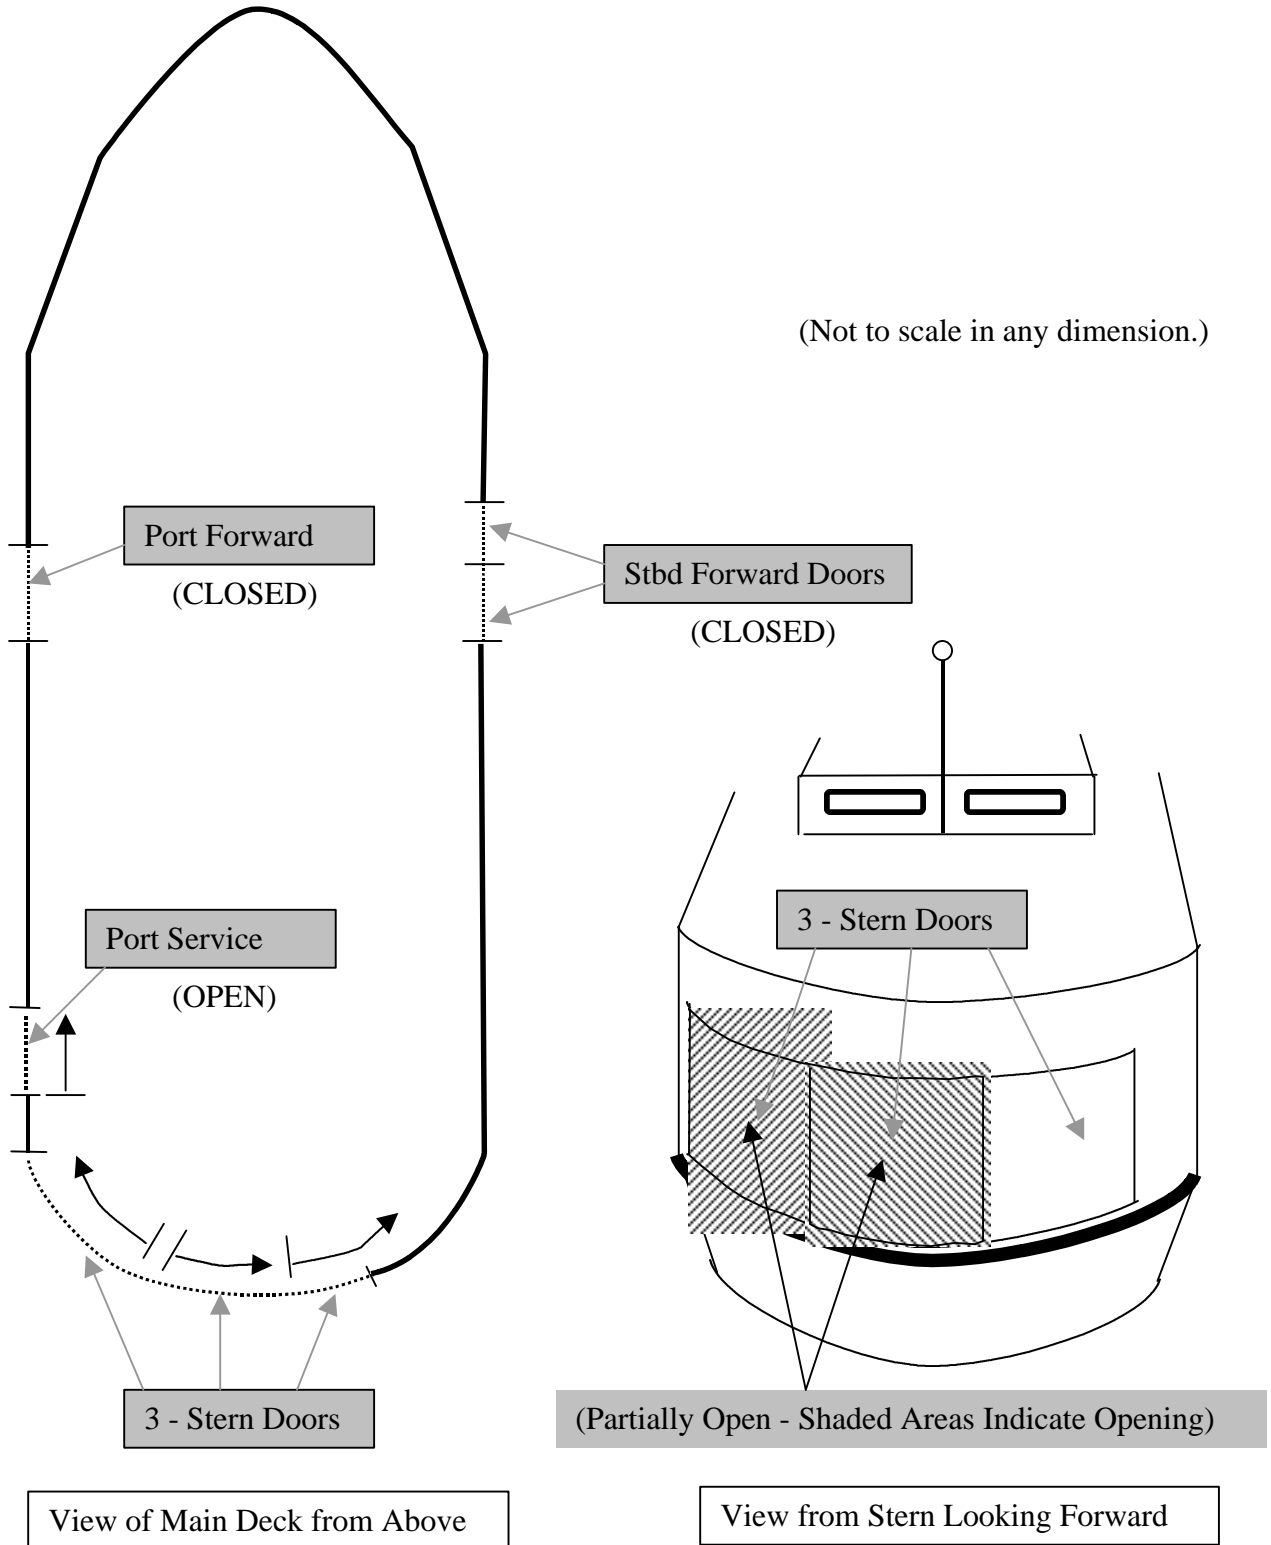
Figure (1): Door Locations on the LINDA E

3. The service door, located on the aft port side of the LINDA E, was found in the open position. A small tangle of fishing nets can be seen extending just outside this door. See Enclosures (2- A and F)

4. Two of the three stern doors on the LINDA E were found in the open position. The door that slides open to the port side of the vessel was fully open. One of the two doors that slide open to the starboard side of the boat was fully open; the other was partially open. See Figure (1). The spreader bar over which nets are normally set can be seen. A small amount of nets are visible through the stern door. No nets extend through the stern door. See Enclosures (2-B,C)

5. All other doors, including the two doors on the starboard forward side and the one door on the port forward side, were found in the closed position. See Enclosures (2-D,E)
