**UNITED STATES COAST GUARD**

# M/V MISS MAJESTIC

ON LAKE HAMILTON, HOT SPRINGS, ARKANSAS ON  
MAY 1, 1999 WITH MULTIPLE LOSS OF LIFE

**SINKING OF THE M/V MISS MAJESTIC, OFFICIAL NUMBER CG002009,  
ON LAKE HAMILTON, HOT SPRINGS, ARKANSAS, ON MAY 1, 1999,  
WITH MULTIPLE LOSS OF LIFE**

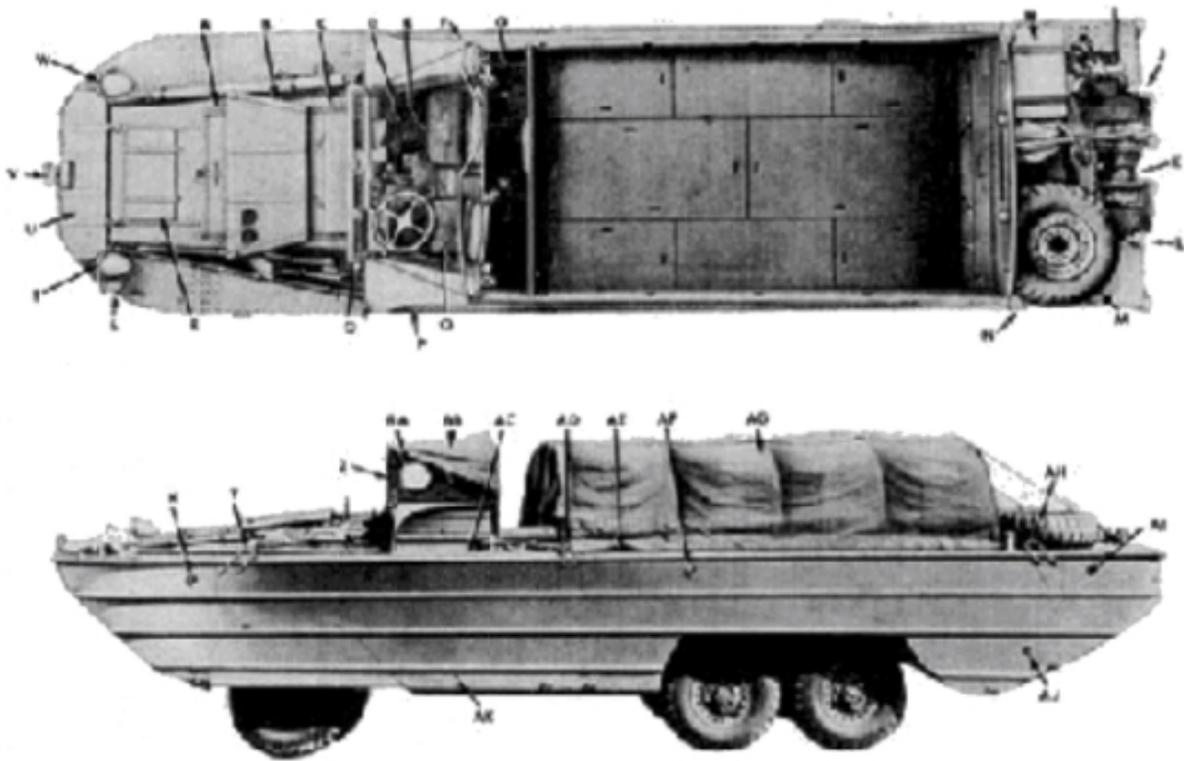
Figure 1: Shows the as-built arrangement and profile. Design clearances above ground were 18 inches to the molded hull and 12 inches to the axles. Design loaded freeboards were 24 inches forward and 16 inches aft. The vessel was fitted with three drive axles, one forward and two aft.

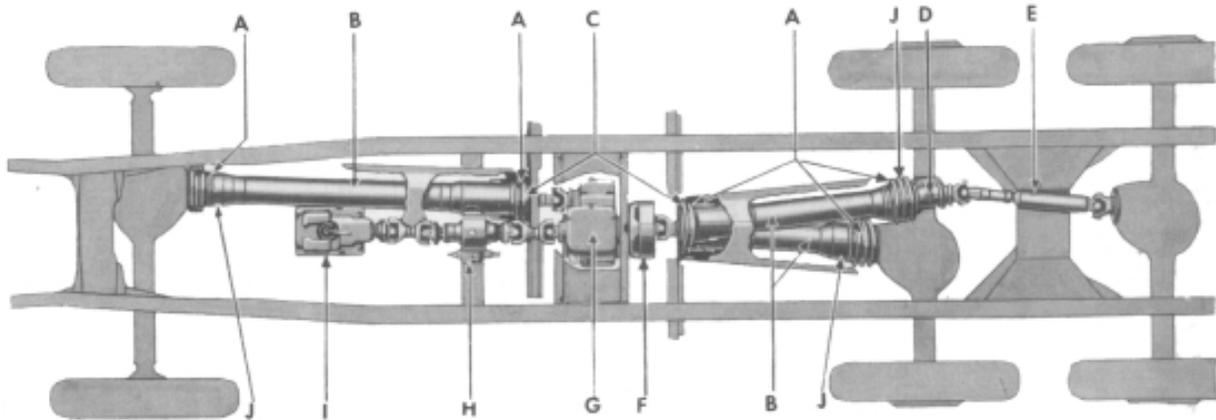
Figure 2: Shows the chassis and drive trains. There were three each 3 inch diameter drain plugs in the molded hull, which also gave access to the engine crankcase, the transmission case, and the transfer case. Each drive shaft was surrounded by a shaft housing, attached to the molded hull and the axle differentials with thin-wall rubber (boot) seals, using a single metal band clamp to secure each boot seal to the shaft housings.

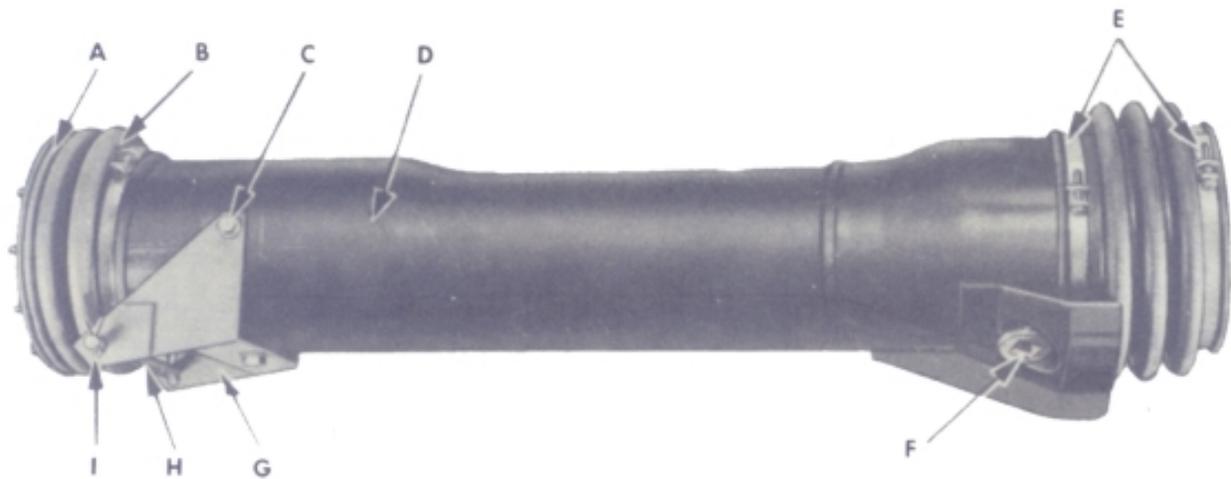
Figure 3: Shows the shaft housing and seals assembly.

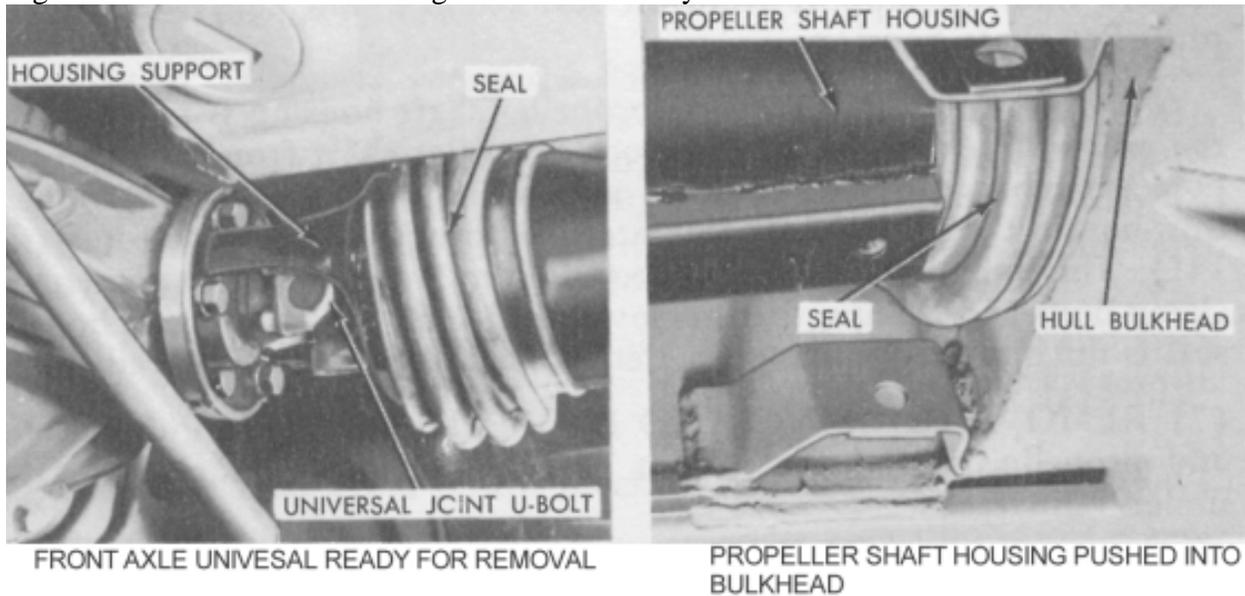
Figure 4a: Shows the housing support at the differential, now informally called a torque tube saddle or a bird cage. Figure 4b: Shows the hull mounts for the shaft housing hinge assembly, near the end of the shaft housing

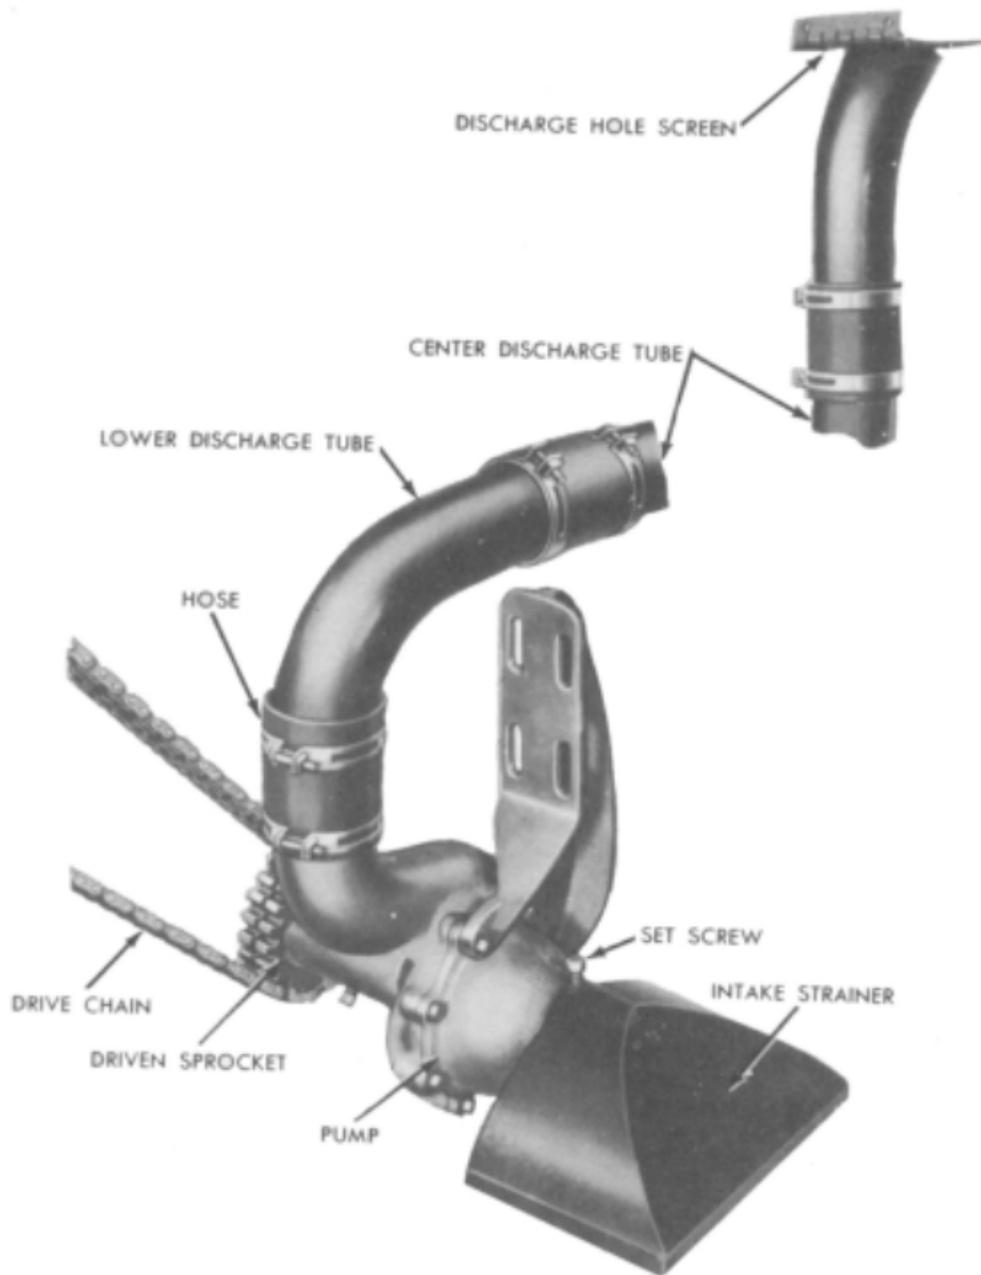
Figure 5: Shows the Higgins bilge pump and its attachments. A Higgins bilge pump was located amidship, port of centerline, and was chain driven (automatic, no operator controls) from the propeller shaft. Bilge piping was originally installed to service three compartments and piped to a bilge pump near the engine.
