Engineroom Fire On Board U.S. Small Passenger Vessel  
*Queen of the West*  
Columbia River, near Rufus, Oregon  
April 8, 2008

**Accident Summary Report**

NTSB/MAR-09/04/SUM  
PB2009-916404

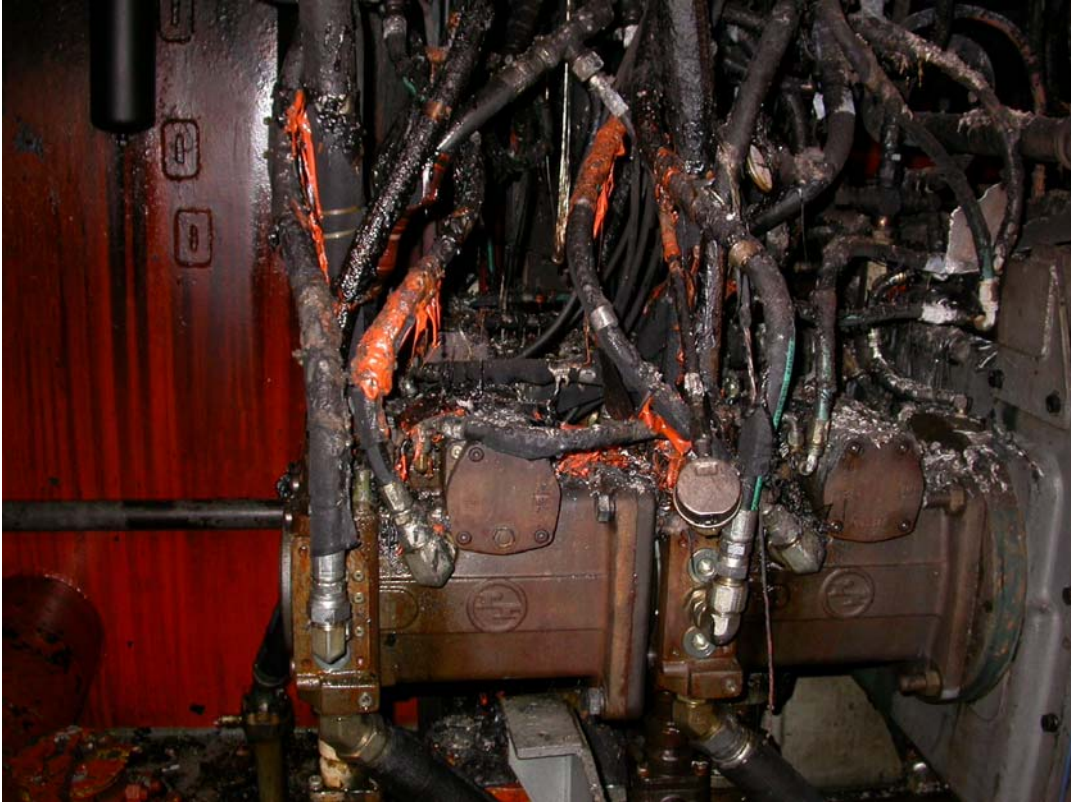
The damage to the vessel was limited to the upper engine level and the adjoining ventilation dampers and vents. The starboard side of the engine room, including the engine and eight hydraulic pumps, sustained significantly less damage than the port side of the engine room, which exhibited heavy fire damage. The space's aluminum bulkhead lining melted away from the overhead and from the upper portion of the bulkhead in the area of the hydraulic pump assembly. Hydraulic pumps 1, 2, and 5–8 on the port side were heavily sooted and had moderate thermal damage (their vibration protection covers had melted). The pumps were covered with hydraulic oil (figure 8).

**Figure 8.** Pumps 1 and 2 and associated hoses for the portside engine.

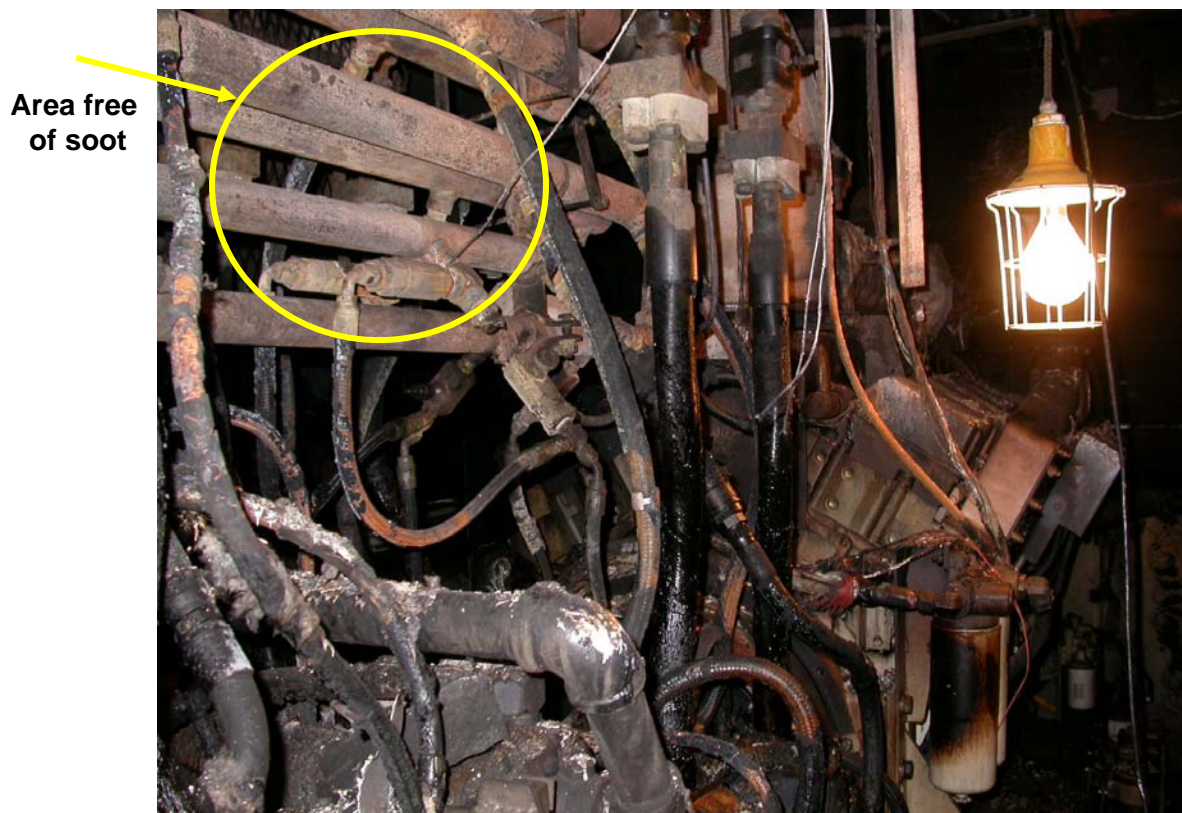
The area near pumps 3 and 4 for the portside engine exhibited heavy thermal damage. Almost no hydraulic oil residue was found on exposed surfaces, and a "clean" area (free of soot) was located directly above pumps 3 and 4, indicating that this area had been exposed to high localized temperatures that burned away the hydraulic oil (figure 9).<sup>19</sup>

<sup>19</sup> If the temperature of a surface (such as metal) exceeds about 750° F, soot cannot attach itself to that surface.

**Figure 9.** Area directly above portside pumps 3 and 4.

Investigators concluded that one of the hydraulic oil hoses that serviced portside pumps 3 and 4 must have failed. Exactly which hose failed and where could not be determined because of the fire damage. Two of the hoses had melted through adjacent to the steel fittings. Portside pumps 3 and 4 and their associated hosing were removed from the vessel for further examination and testing by a third-party forensics-testing laboratory. The pump examination found no leakage around the seals and connections. Because of the fire damage, the hoses could not be pressure-tested for preexisting holes or leaks.

Following the accident, Majestic America Line installed heat shields between the hydraulic pumps and the propulsion engines on the *Queen of the West*. This was done to prevent flammable liquids from spraying onto the engine in the event of a hose or pump failure. Majestic America Line also took steps to insulate all exposed exhaust piping surfaces in the engine spaces.

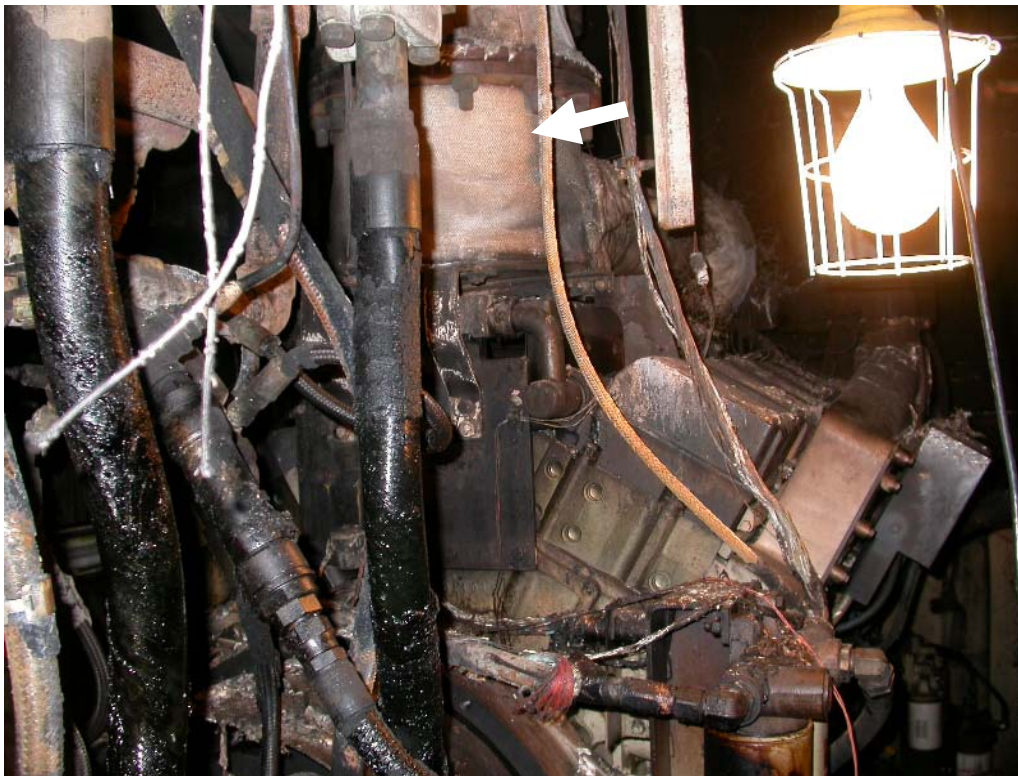
Also located in the area of portside pumps 3 and 4, above and immediately aft, was the steel exhaust piping for the port propulsion engine (figure 10).

**Figure 10.** The exhaust piping onto which hydraulic oil sprayed and ignited. The piping can be seen in the upper center of the photo, with an arrow pointing to it.

Because of the proximity between the hydraulic oil hoses and the hot exhaust piping, and because of the lack of alternative ignition and fuel sources in the immediate area, investigators determined that the fire was caused by hot surface ignition of hydraulic oil. The hot exhaust piping was the fire's ignition source and the paddlewheel hydraulic oil—Synterra oil by ConocoPhillips—from the failed hydraulic hose was the fire's fuel source. Synterra oil's auto ignition temperature is about 657° F. Because the hydraulic oil leak was in the form of atomized<sup>20</sup> spray, it created a fuel-air mixture that ignited when it came in contact with the near-800° F exhaust piping.
