National Transportation Safety Board

Marine Accident Brief

Accident No.: DCA-09-CM-001

Vessel: U.S. commercial fishing vessel *Katmai*, official number 918779, overall length 92.2 feet, registered length 73.3 feet, beam 26 feet, 148 gross register tons, 101 net tons, built 1987

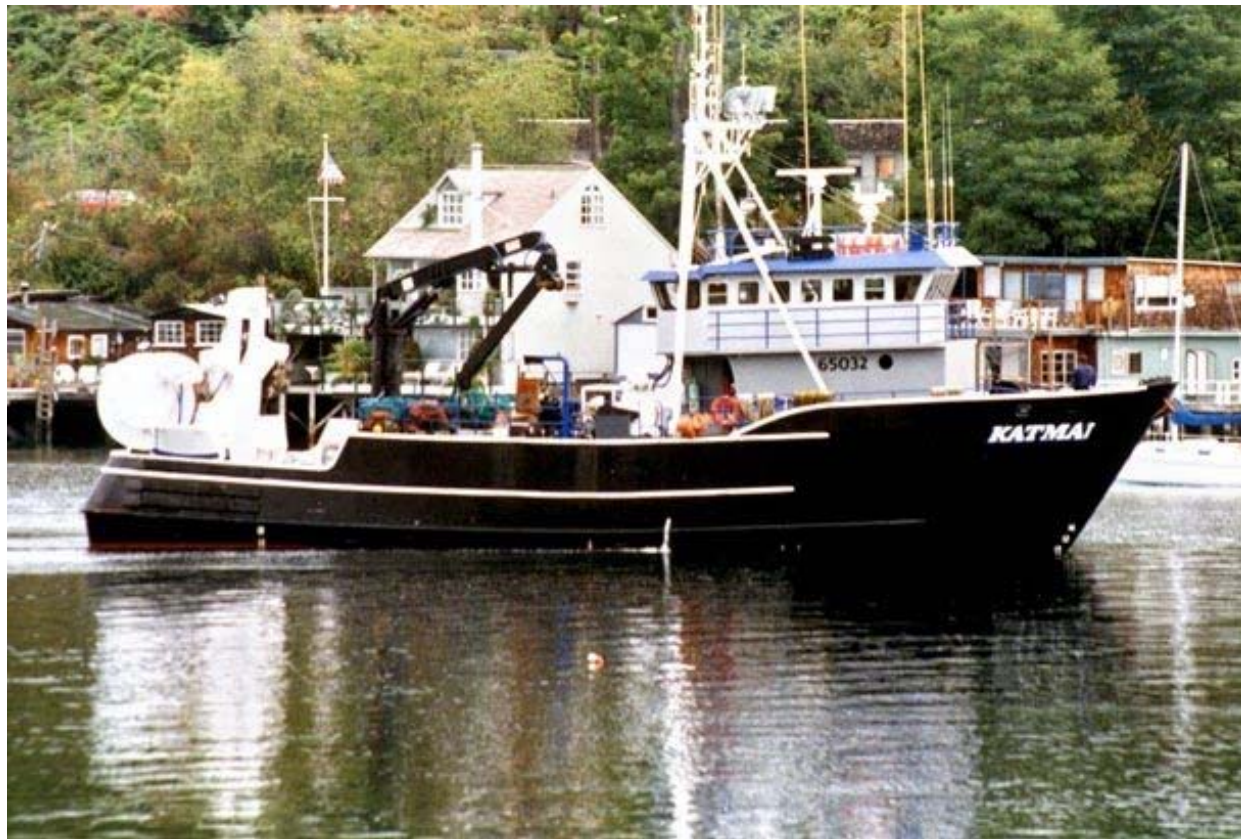
Figure 1. Fishing vessel *Katmai* motoring through Ballard locks in Seattle (undated *Seattle Times* photo). White cylindrical structure (net reel) at stern was later removed when vessel was refitted for cod fishing. *Katmai* was the only vessel owned and operated by Katmai Fisheries, Inc.
