## Marine Accident Brief

**Accident No.:** DCA-09-LM-010

**Vessel:** U.S. commercial fishing vessel *Lady Mary*, official number 520834, 76-foot length overall (71.2-foot documented length), 105 gross registered tons, 21.2-foot beam steel construction, built 1969, converted 2001

**Accident Type:** Sinking

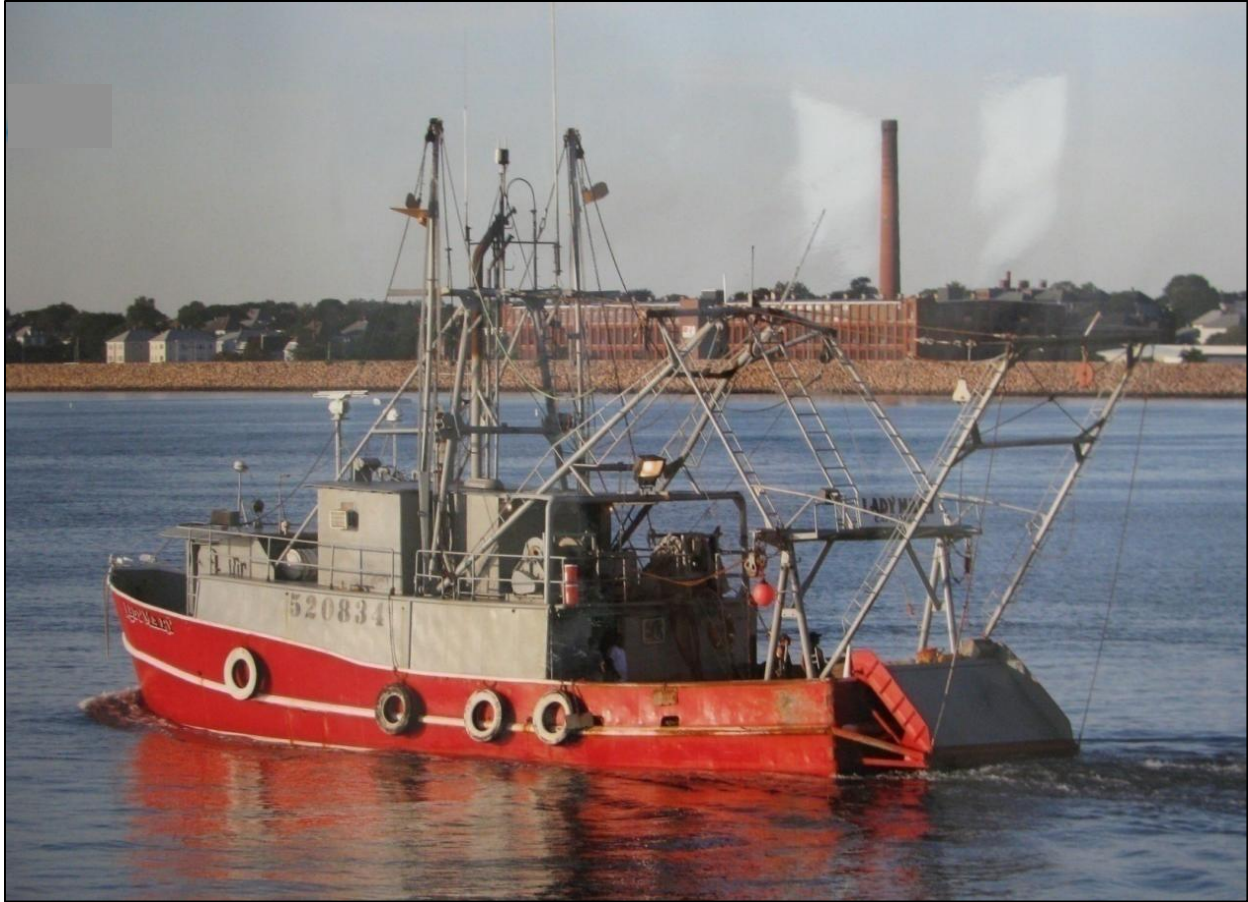
**Figure 1.** Fishing vessel *Lady Mary* outbound from New Bedford, Massachusetts, July 2006. (Photo by Steven Kennedy of *Commercial Fisheries News*)

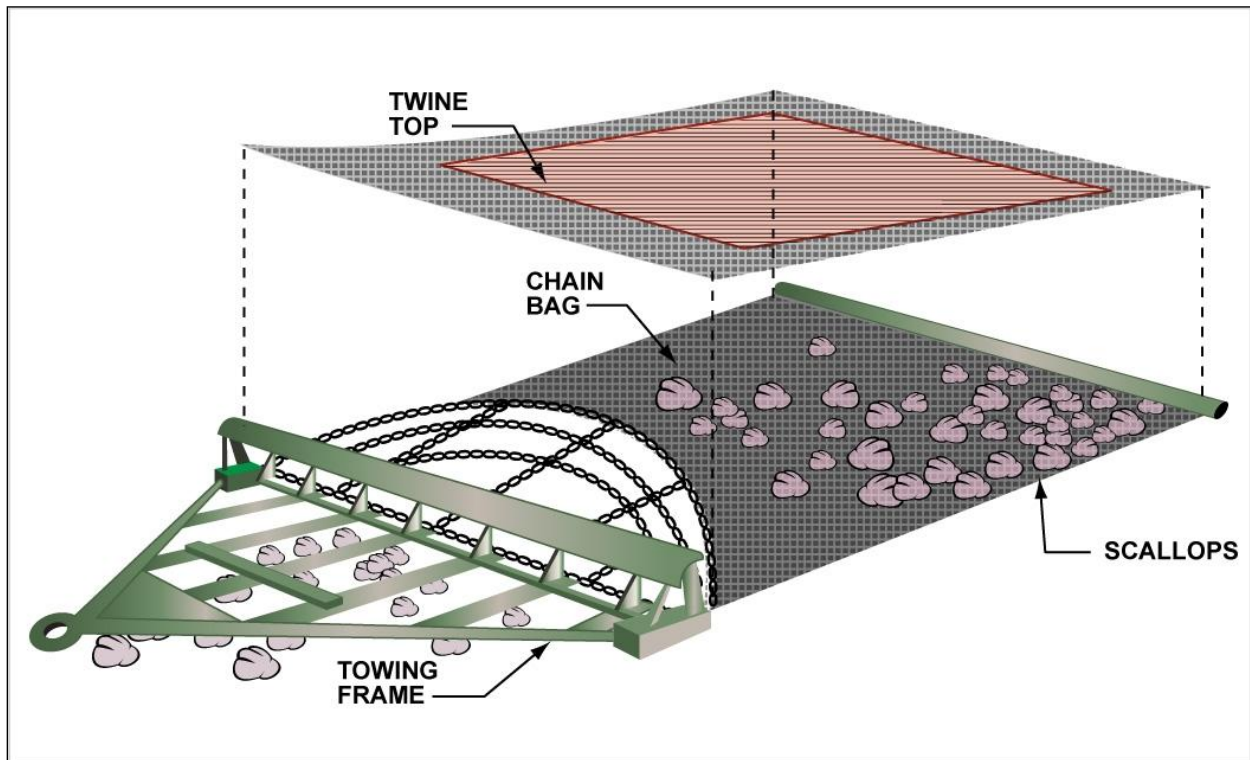
The vessel's shrimp net was also replaced with a scallop dredge. The dredge consisted of a heavy steel towing frame and a chain bag that dragged along the ocean floor behind the vessel (figure 5). At the end of a towing run, the crew would hoist the dredge on board, empty the bag, and shuck the scallops while the dredge was being towed again. The shucked scallops were kept on ice in the vessel's fish hold awaiting transport to shore.

**Figure 5.** Scallop dredge, with twine top removed for illustrative purposes. Front of towing frame rides off sea floor, chain bag drags on bottom, and bar at rear maintains bag's shape.<sup>8</sup>
