Engineroom Fire On Board U.S. Small Passenger Vessel  
*Queen of the West*  
Columbia River, near Rufus, Oregon  
April 8, 2008

**Accident Summary Report**

NTSB/MAR-09/04/SUM  
PB2009-916404

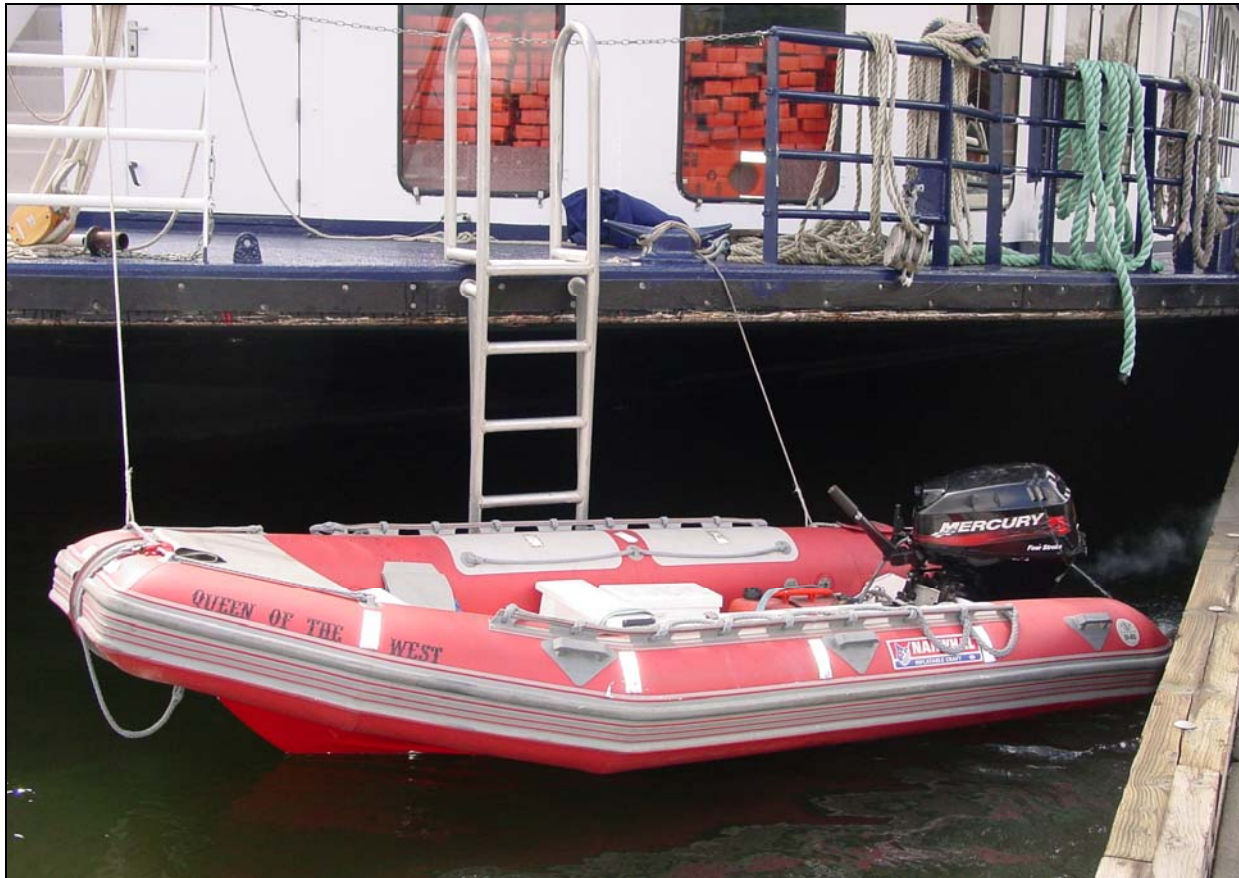
The riding captain was standing by to evacuate the passengers from the vessel. An evacuation to shore,<sup>12</sup> if necessary, would have had to use the vessel's sole rescue boat (figure 6), which, according to the vessel master, could accommodate six persons at a time, two of whom had to be crewmembers. Therefore, the rescue boat would have had to make numerous trips—conveying four passengers at a time—unless other help became available. Because the fire was later suppressed and because the towboat *Challenger* was en route to assist, the *Queen of the West* did not need to be evacuated in the rescue boat, and the passengers were so informed.

**Figure 6.** The rescue boat positioned at the *Queen of the West*'s port forward side.

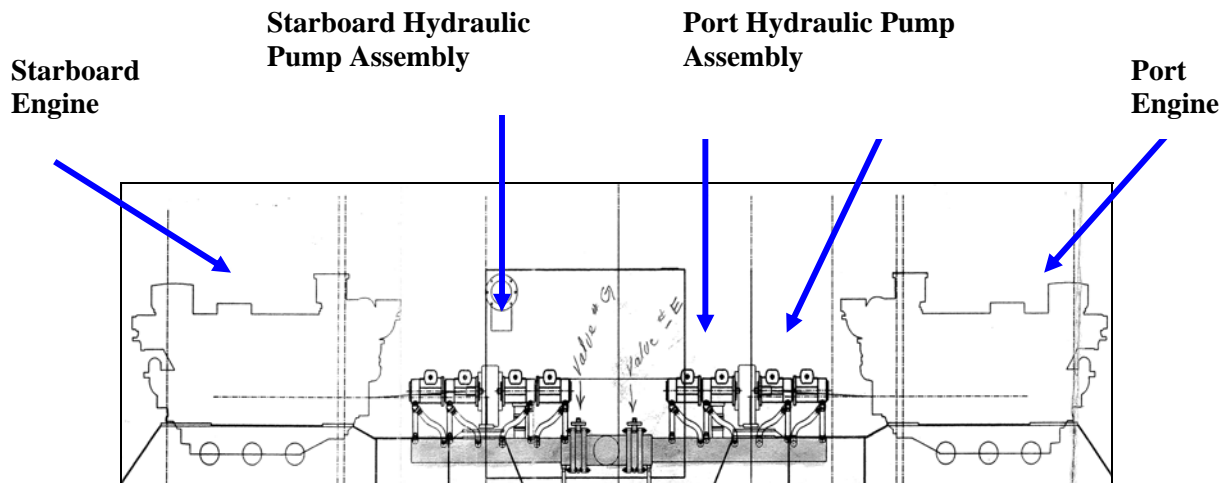
contained the vessel's two diesel-driven electrical generators, which supplied AC power throughout the vessel and powered the bow thruster. The upper level of the engine room contained most of the vessel's propulsion machinery (figure 7). The machinery consisted of two main propulsion engines of 1,600 horsepower each, one on the starboard side and one on the port side. Each engine supplied power to the vessel's propulsion system, which comprised eight hydraulic pumps sequentially attached to each engine.

Figure 7. Upper engine level configuration, facing aft.
